1. CASE NUMBER 9 6 0 8 0 7 C A A 7 3 4 8		2. INVESTIGATOR'S ID 8 0 9 0		EPIDEMIOLOGIC INVESTIGATION REPORT
3. OFFICE CODE 8 6 0	4. DATE OF INCIDENT 9 6 0 7 2 7	5. DATE INITIATED 9 6 0 8 1 3

6. SYNOPSIS OF INCIDENT OR COMPLAINT An electric toaster oven was being used to toast two bagels. The consumer noticed flames coming from the electrical compartment of the toaster oven, within about thirty seconds of starting the unit. He noticed the flames before the fire spread beyond the toaster oven. The consumer unplugged the toaster oven, and he then brought the unit outside the house, throwing it to the ground. No one was injured, in this fire and there was no fire damage to the home.

7. LOCATION(Home,School,etc.) Home (Kitchen) 1 0		8. CITY Prunedale		9. STATE California C A
10A. FIRST PRODUCT Electric Toaster Oven 0 2 1 6		10B. TRADE/BRAND NAME Black & Decker (brand)		10C. MODEL NUMBER Model: TR200TY1
10D. MANUFACTURER NAME AND ADDRESS Black & Decker (U.S.) Inc., 6 Armstrong Road, Shelton, CT 06484				
11A. SECOND PRODUCT None known - - - -		11B. TRADE/BRAND NAME - N/A -		11C. MODEL NUMBER - N/A -
11D. MANUFACTURER NAME AND ADDRESS - N/A -

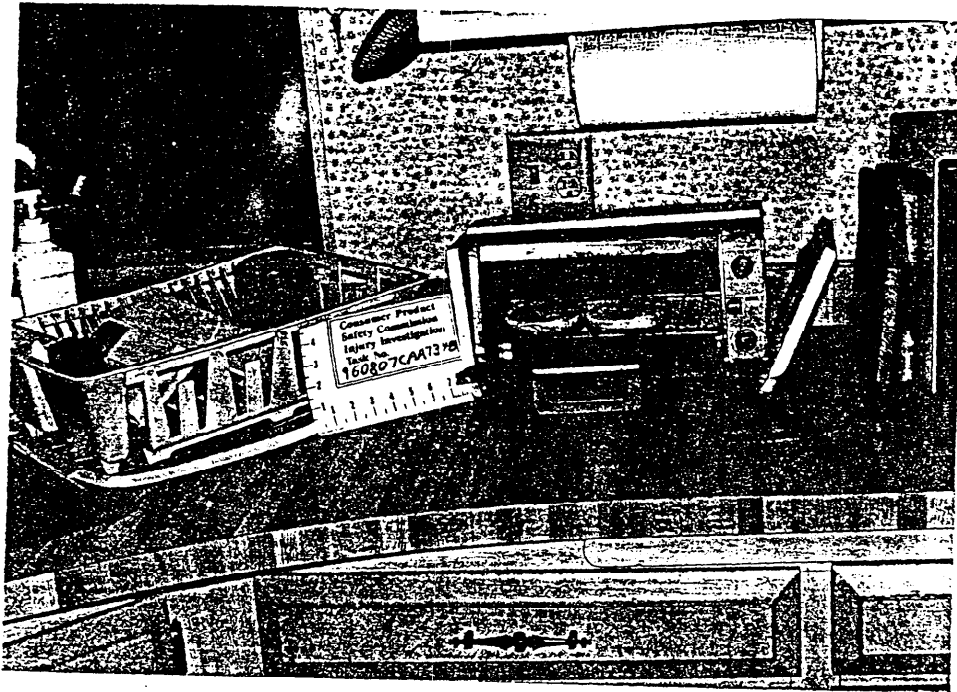
PHOTO #1: Photograph of the scene of this fire incident, with the electric toaster oven placed in the position that it was at the time of the fire.

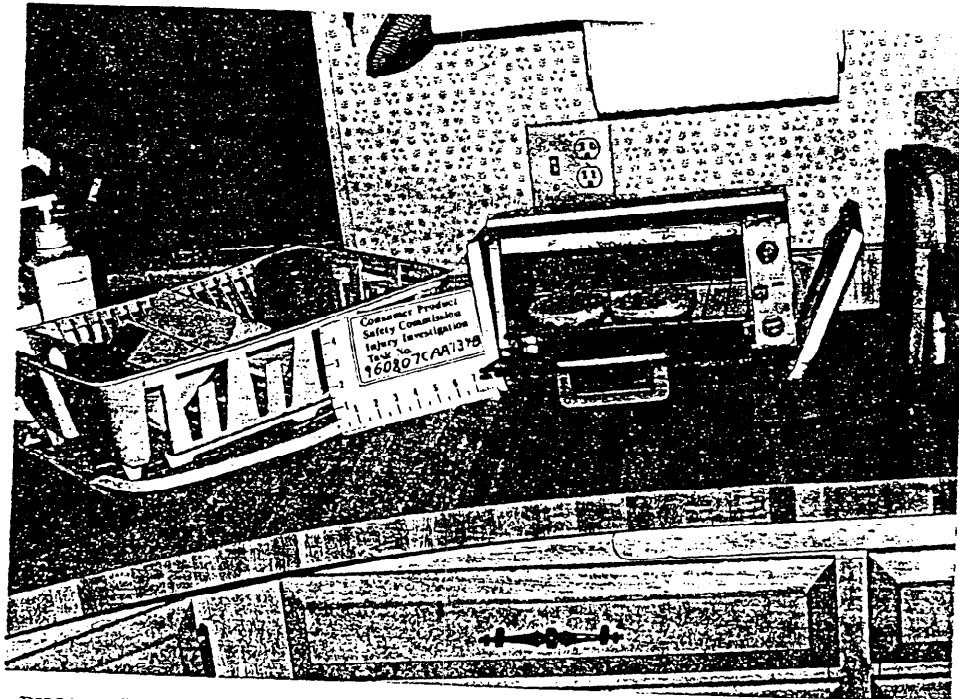
PHOTO #2: Another photograph of the scene as shown in PHOTO #1 above. The electric toaster oven's plug had been plugged into the electrical outlet just behind the toaster oven.

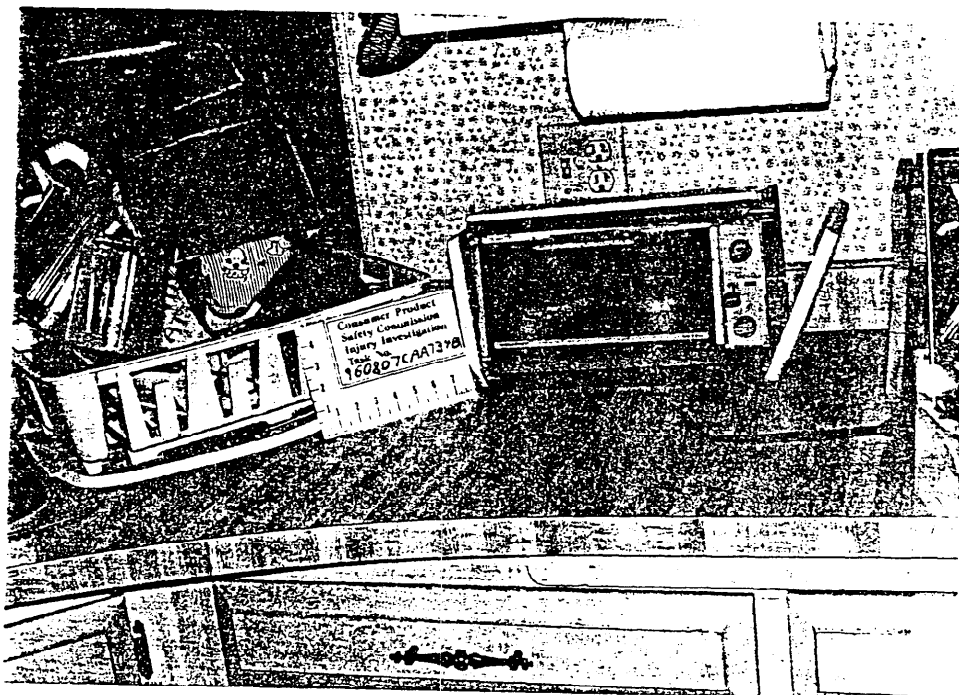
PHOTO #3: Another photograph of the scene of this fire incident. The bagels were placed into the toaster oven as shown in this photograph.

During the on-site visit, the husband was asked about the bagels that were inside the toaster oven, during this fire incident. He said that the bagels were the same as shown inside the toaster oven in PHOTOS #1 to #5 of EXHIBIT I. This bagel is cut in half. Each half was measured to be roughly 3 & 3/4 inches in diameter and about 3/4 inches thick. The bagel halves did not catch on fire during this fire incident.

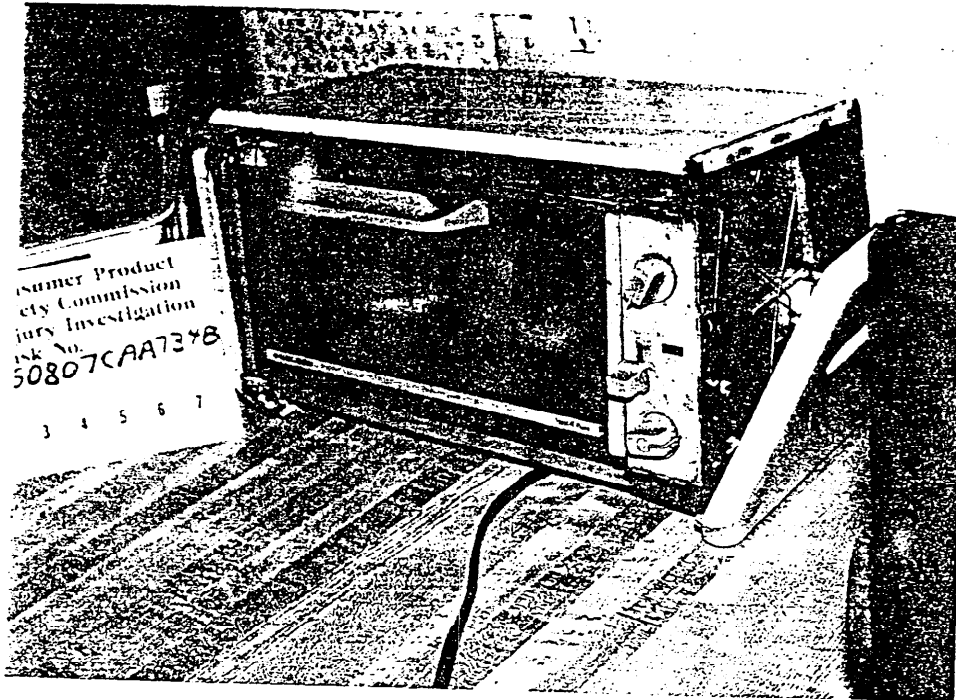
PHOTO #5: Close-up photograph of the electric toaster oven.

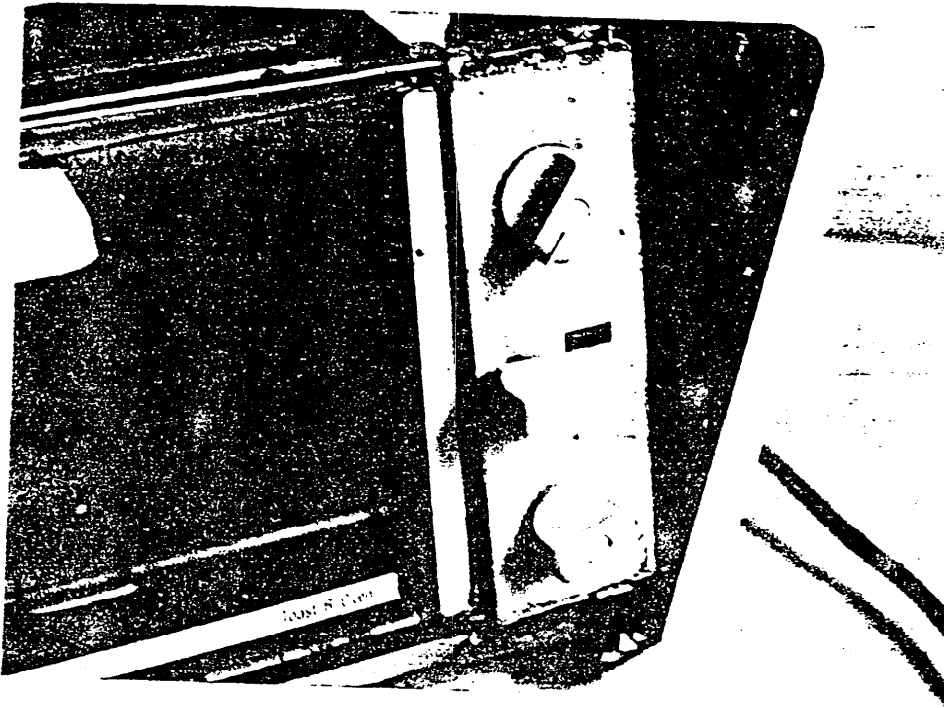
PHOTO #7: Close-up photograph of the controls on the toater oven. The toast color selector was on the "Top Brown" setting. The oven control was "Off". The Toaster On/Off Control Lever was pushed down.

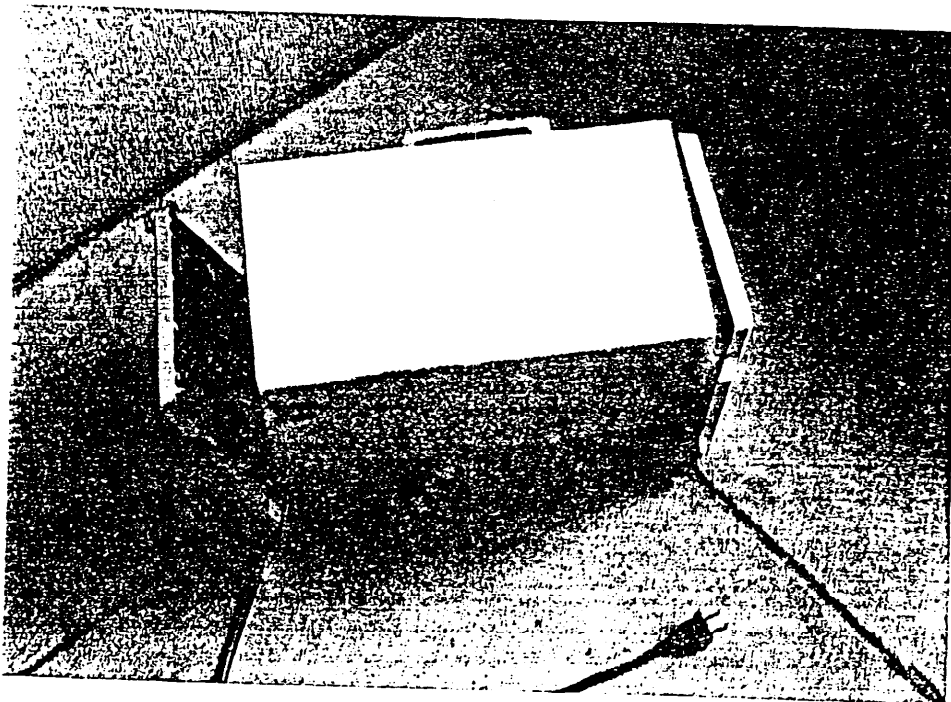
PHOTO #8: Photograph of the back of the back and top of the electric toaster oven. The sides broke open, when the consumer threw the oven to the ground outside of his home, while he was removing it from the house (during this fire incident).

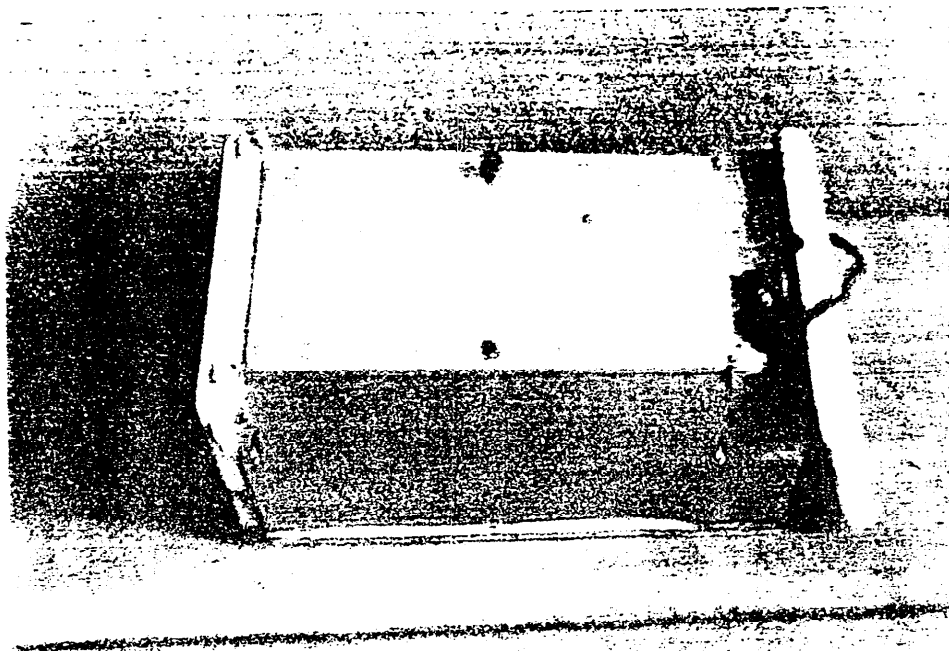
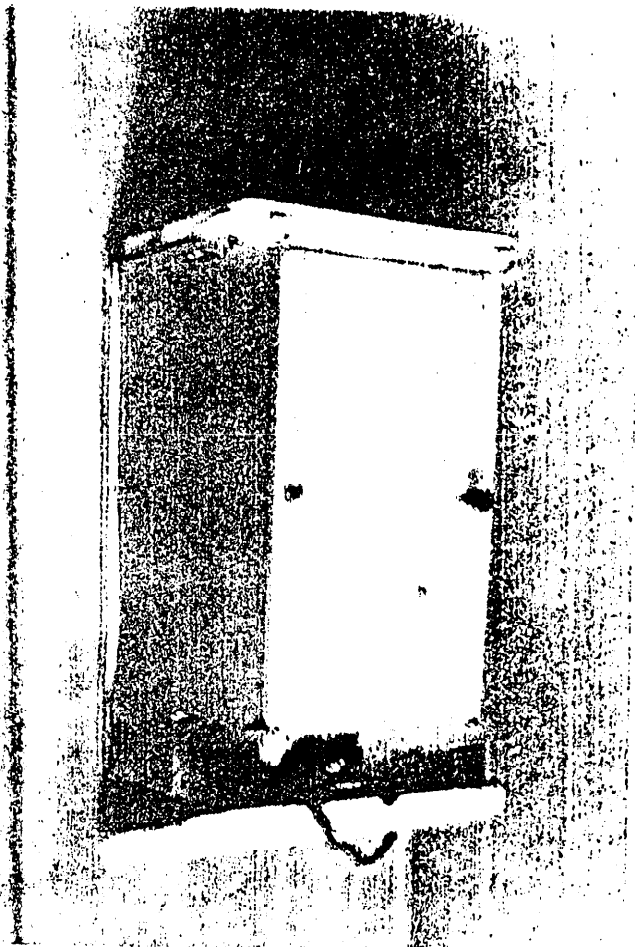
PHOTO #11: Photograph of the bottom and the back of the toaster oven.

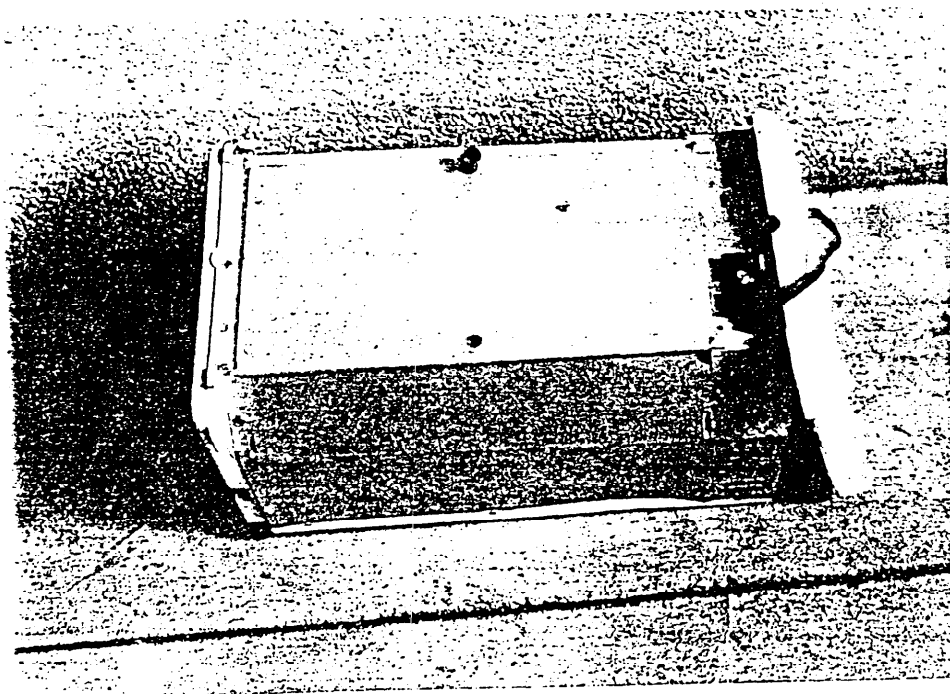
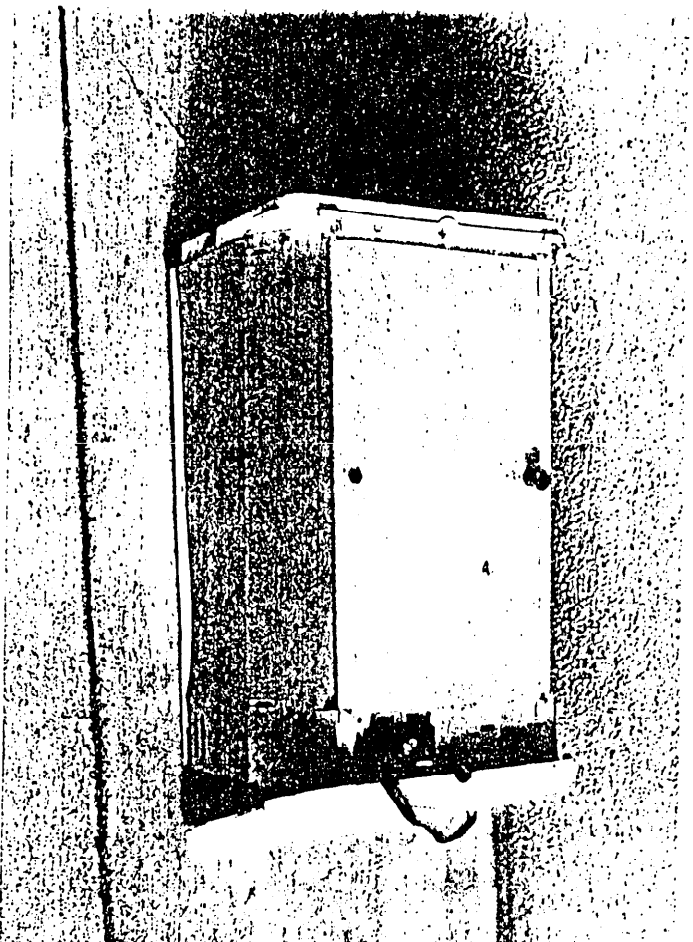
PHOTO #12: Photograph of the bottom and back side of the toaster oven.

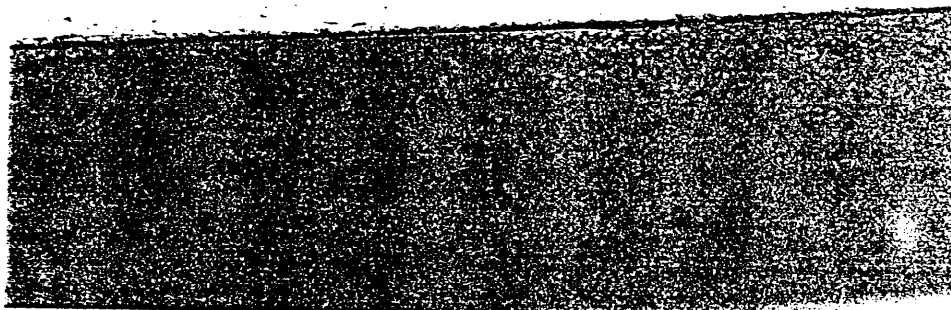
PHOTO #15: Close-up photograph of the "BLACK & DECKER" mark on the toater oven's back metal cover. Additional marks are hard to read. The additional marks appear to be: MODEL NO. TR200TY1.

The back metal of the toaster oven is marked in-part: "BLACK & DECKER"; "MODEL NO. TR200TY1" (these numbers are hard to read); "SHELTON, CONN." [see PHOTOS #15 & #16 of EXHIBIT I]. The front cover of the USE & CARE BOOK lists: "Model TRO200".

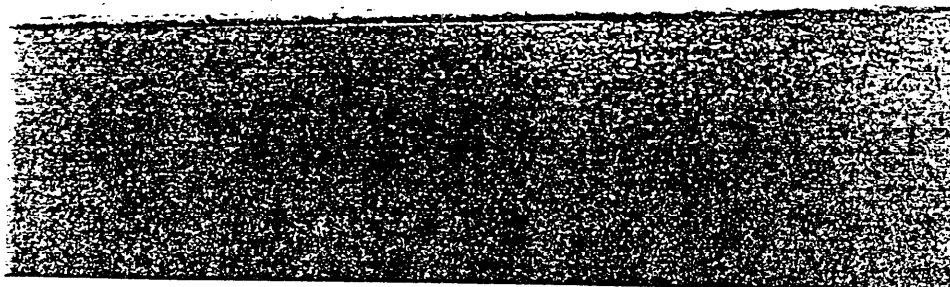
PHOTO #16: Below the model number appears to be: "SHELTON, CONN."

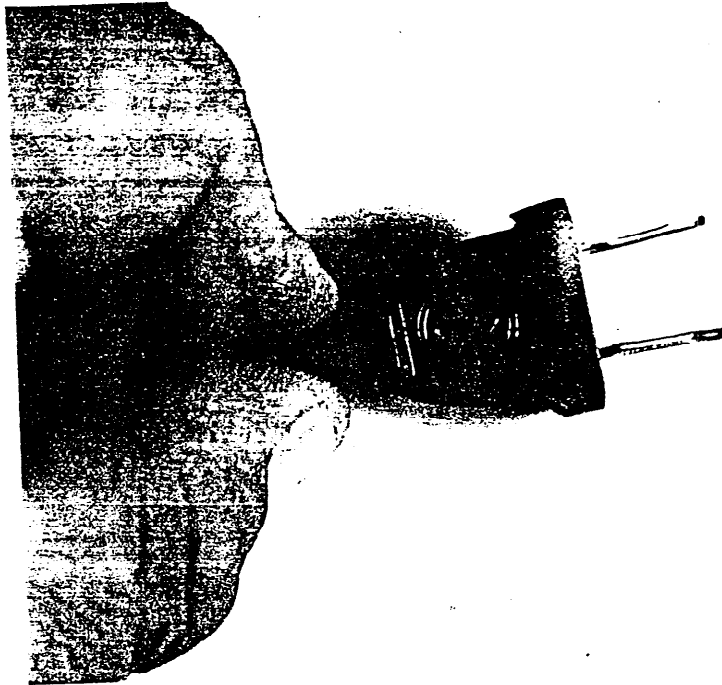
PHOTO #21: Close-up photograph of the power cord's plug.

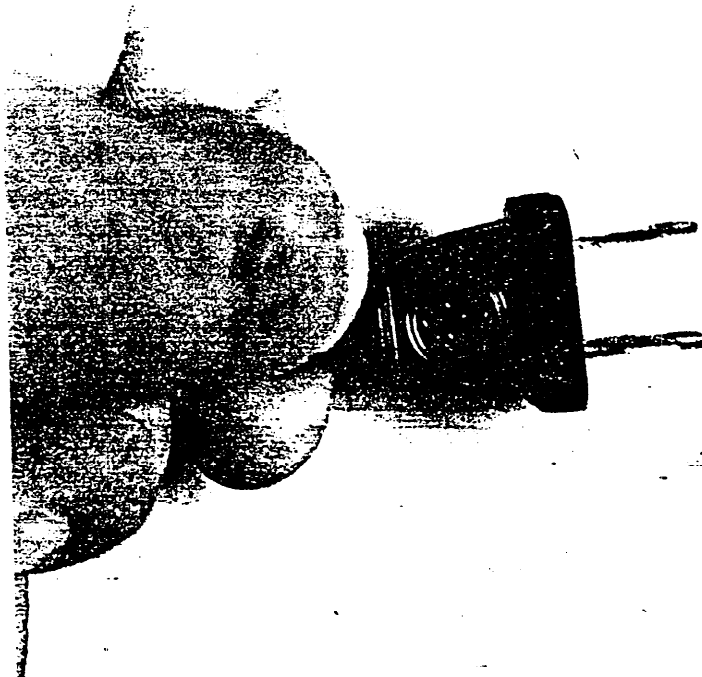
PHOTO #22: Another photograph of the toaster oven's power cord male plug.

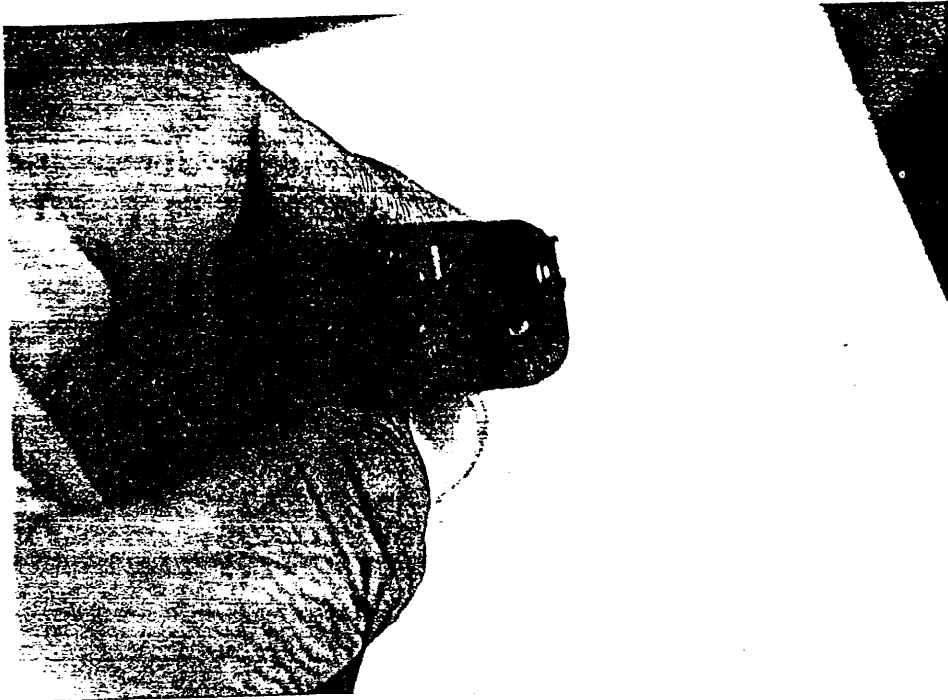
PHOTO #23: Close-up photograph of the toaster oven's power cord's male plug. The plastic has a v and a "5" molded on the end of the plug.

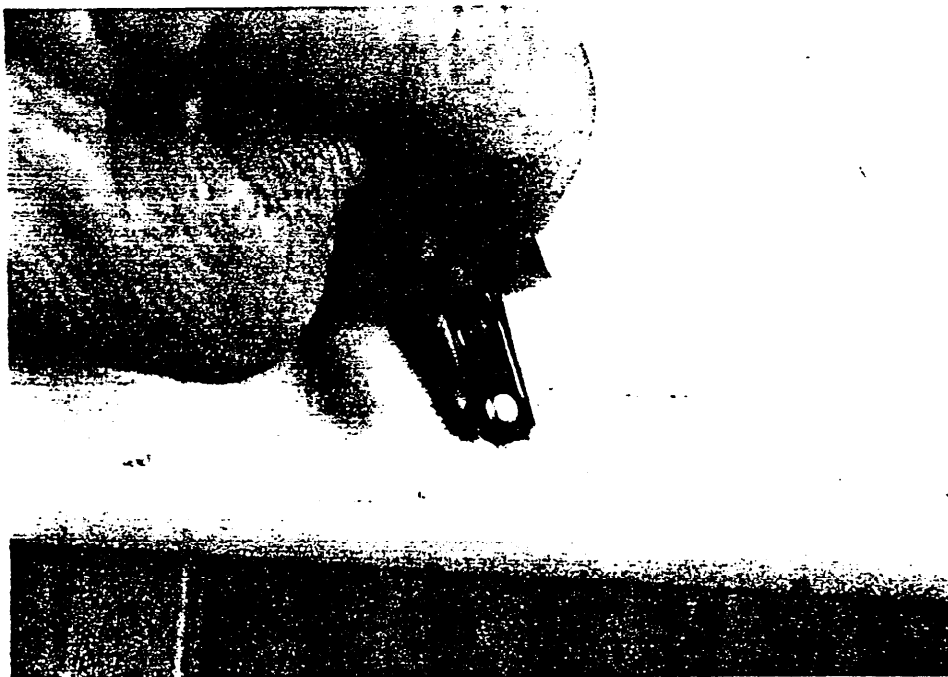
PHOTO #24: Close-up photograph of one of the metal prongs of the power cord's plug, shown in PHOTO #23 above. This metal prong has a mark, which appears to be "123" on the metal prong.

The wife did call Black & Decker to alert them about this incident. She called about one week after this incident. She reports that the respondent at Black & Decker indicated that marks on the power cord (or power cord's plug) will identify the model of the toaster oven, so she should remove the power cord and send it to Black & Decker. Black & Decker promised to send them a free replacement toaster oven, upon Black & Decker's receipt of the unit's power cord. The consumers were not certain exactly where the marks are located on the power cord's plug. Examining the power cord's plug revealed a " v " (on the plastic portion). There also appears to be a "5" (on the plastic portion). One of the plug's metal prongs appears to be marked: "123". The power cord is marked: "VICTOR CORP. --- VEWC CORP. 16/2 AWG TYPE HPN HEATER CORD CPE".

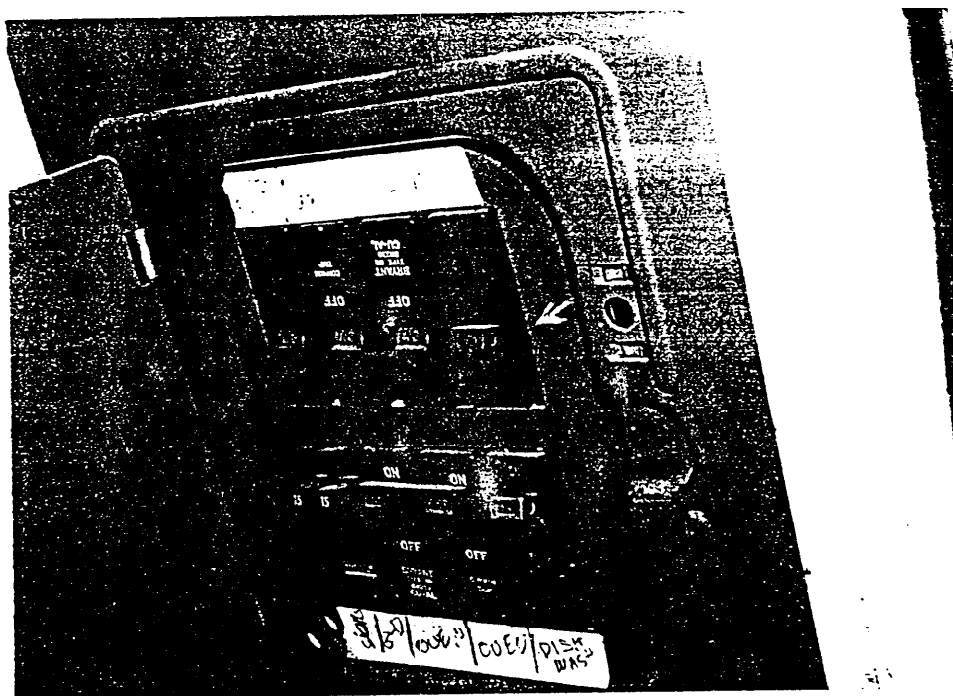
PHOTO #25: Photograph of the circuit breaker box in the consumer's home. The breaker (next to the arrow scratched on the photograph) protects the branch circuit, inwhich the toaster oven was plugged into during this fire incident. This circuit breaker is a 20 AMP circuit breaker ("BRYANT" brand). It did not trip during this incident.

The husband immediately unplugged the electric toaster oven's power cord, upon seeing the flames coming out of the unit. He then ran outside, carrying the unit, and threw the unit to the ground outside of the house. The husband was able to remove the electric toaster oven from the house, before anything caught on fire. He reports that the electric toaster oven was located, just below the paper towels and kitchen cabinets. The paper towels had not yet ignited from the flames coming from the electric toaster oven. The husband said that he discovered this fire incident, just at the time that it was starting. There was no fire damage to the consumers' house and no one was injured in this fire incident. The husband reports that the 20 Ampere circuit breaker (Bryant brand), which protected the electrical outlet where the toaster oven was plugged, did not trip at the time of this fire incident.
